APR 81 B O TARAN, C S ANDERSON, J G STARR

Name Of Dam: MCGHEE  
Location: LOUDOUN COUNTY  
Inventory Number: VA 10706

## PHASE I INSPECTION REPORT NATIONAL DAM SAFETY PROGRAM

Name of Dam: McGhee Dam  
State: Virginia  
Location: Loudoun County  
USGS Quad Sheet: Blument, Virginia  
Stream: Tributary to Beaverdam Creek  
Date of Inspection: 29 April 1981

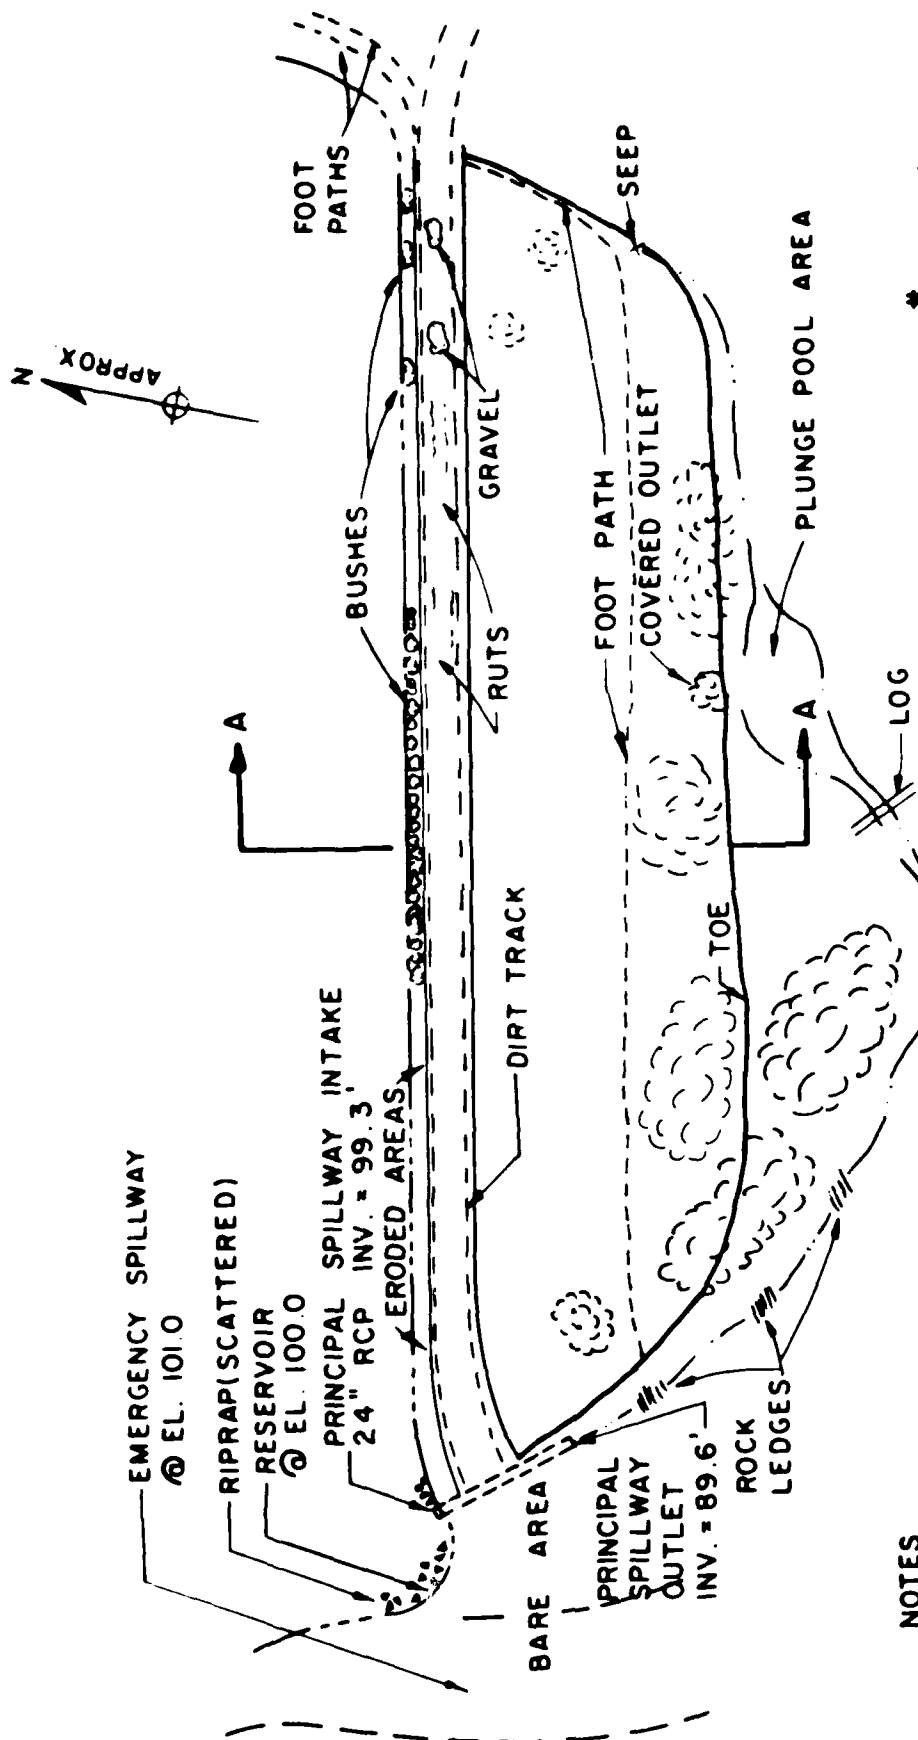
## PLAN VIEW OF THE DAM

3.1.2 Embankment: The embankment is in good condition. A sketch showing a plan view, a profile of the crest, and a cross section are provided in Appendix I. An overview view of the dam is provided at the beginning of the report.
